PERFORMANCE AND LONG DURATION TEST OF A 30 KW THERMAL
ARCJET ENGINE (U) JET PROPULSION LAB PASADENA CA
T J PIVIROTTO ET AL. NOV 87 JPL-D-4643 AFAL-TR-87-010

Performance and Long Duration Test of a 30 kw Thermal Arcjet Engine

November 1987

Jet Propulsion Laboratory

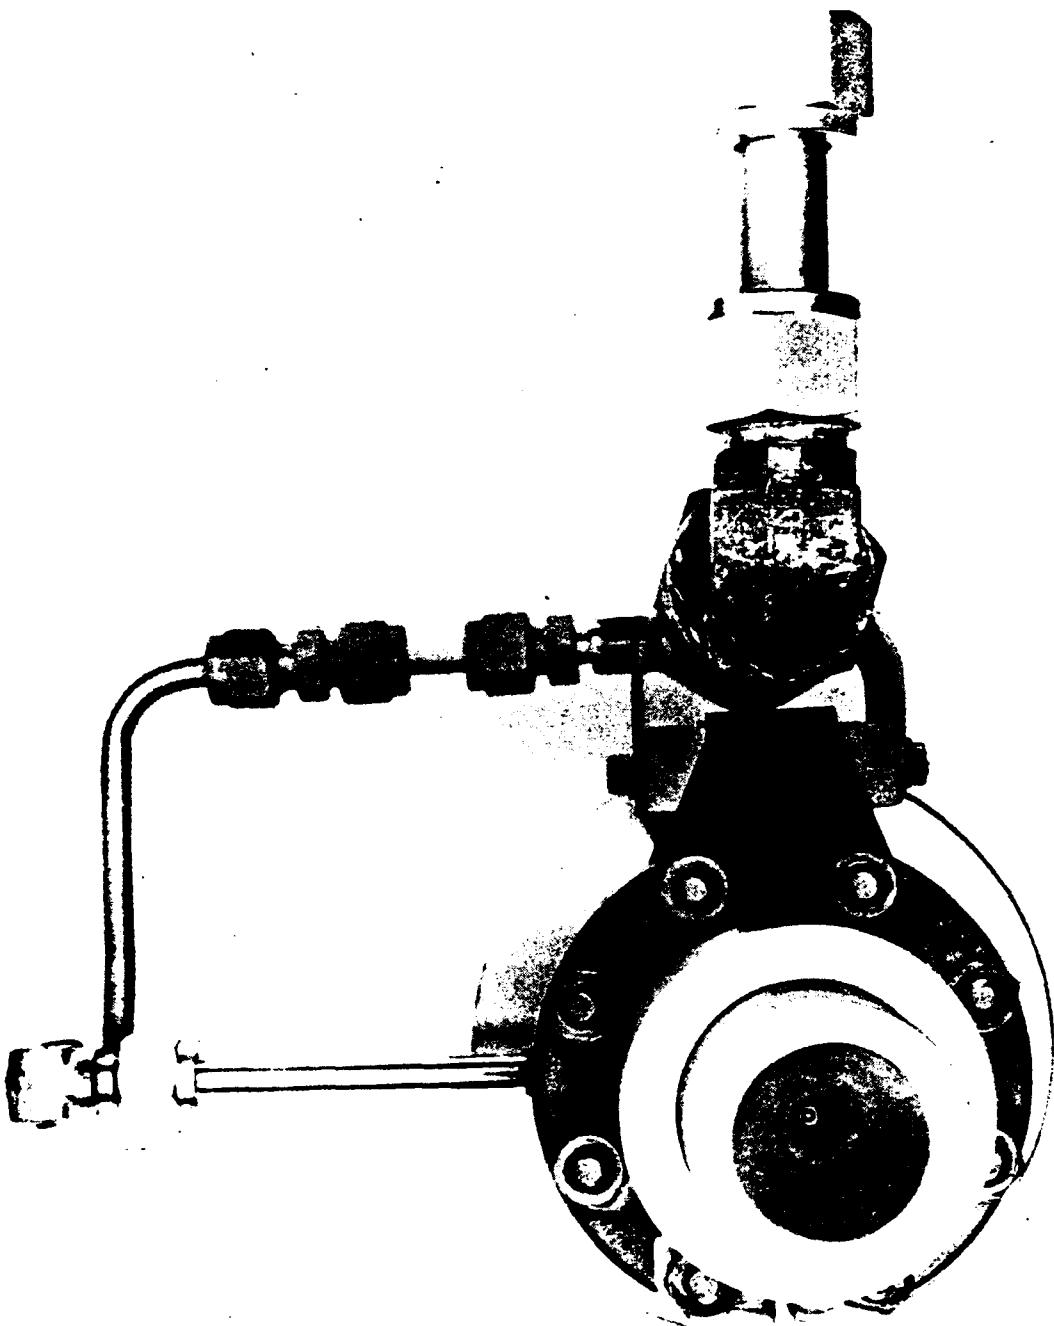
In order to repair the coaxial current feed system, the arcjet engine was removed from the thrust stand. The engine was not disassembled but it was photographed and the eight bolts tightened since they were found to be very loose. This loosening probably occurred during the engine cool-down since there is no noticeable voltage drop during the hot run, which would occur if a propellant leak had opened up. The thermal expansion of the boron nitride, Inconel 600 and titanium was greater than the molybdenum bolts (see Fig. 9), possibly causing further compression of the graphite gaskets and/or creep in the threads of the steel nuts.

Figure 30. Photograph of Entire Engine After 109 Hours of Continuous Operation at 29 kW

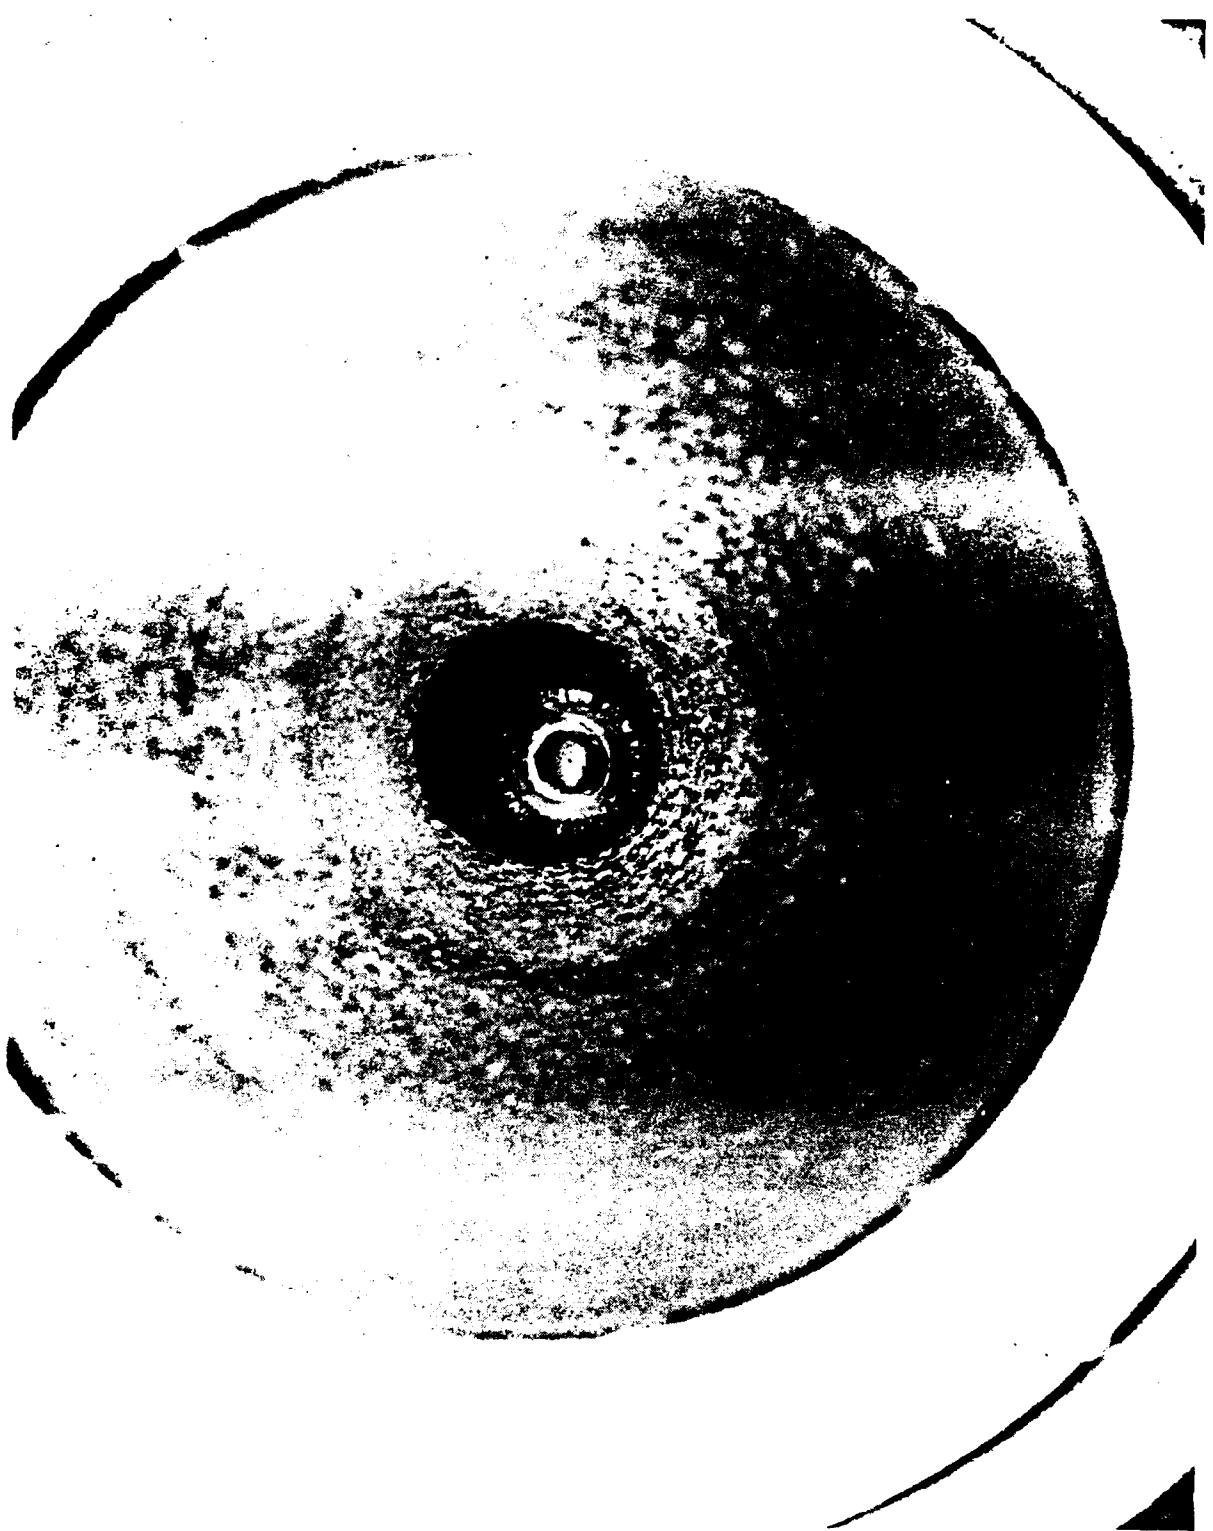
Figure 31. Photograph of Nozzle, Constrictor and Cathode
after 109 Hours of Continuous Operation at 29 kW

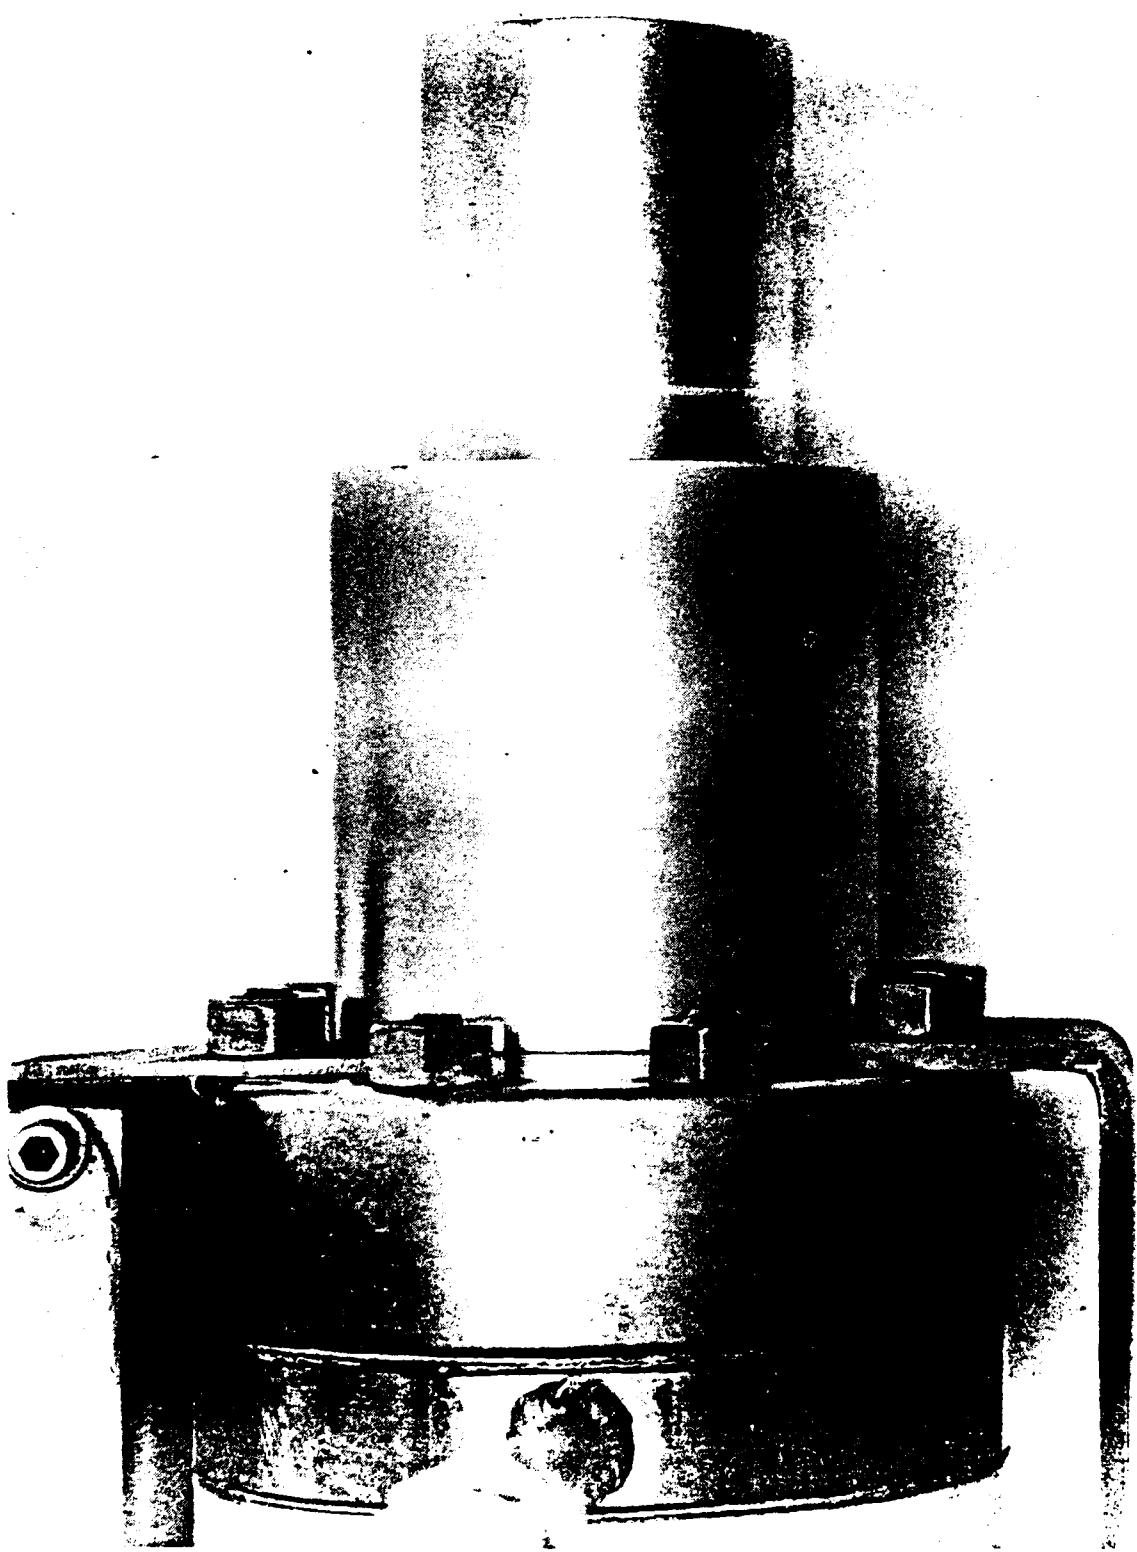
Figure 32. Photograph of Entire Engine After 369 Hours of
Accumulated Run Time

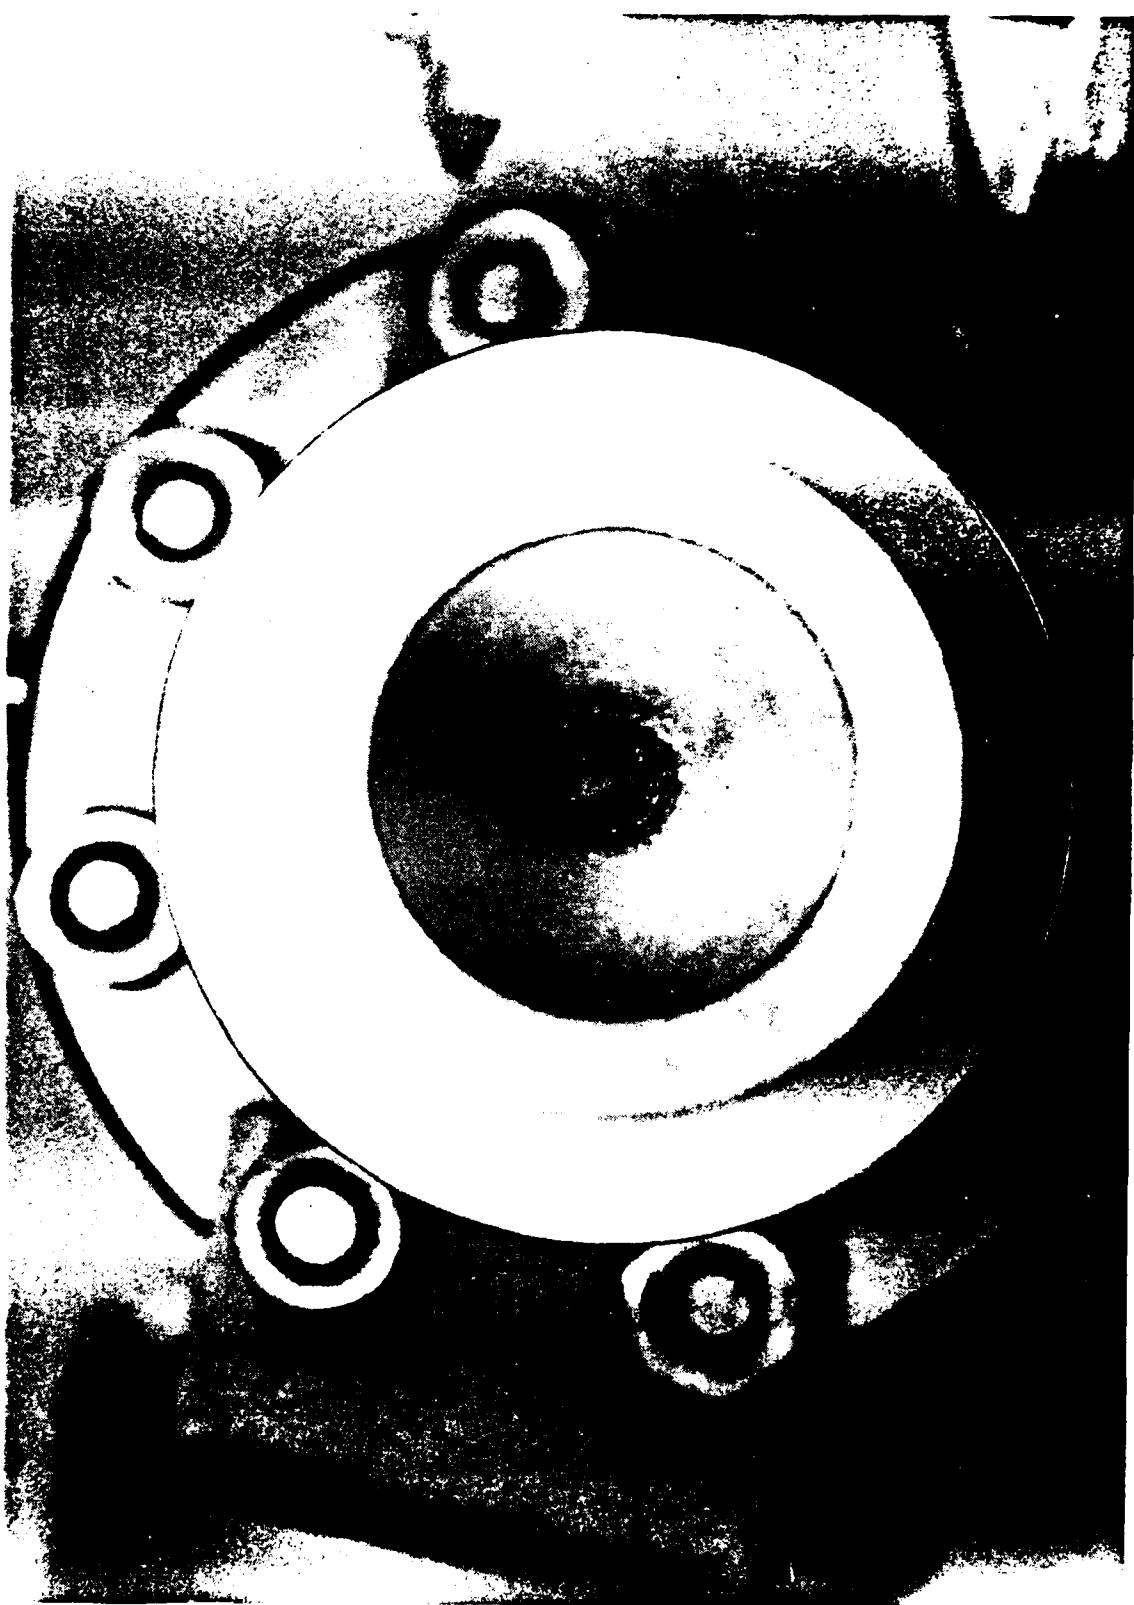
Figure 33. Photograph of Nozzle, Constrictor and Cathode
after 369 Hours of Accumulated Run Time

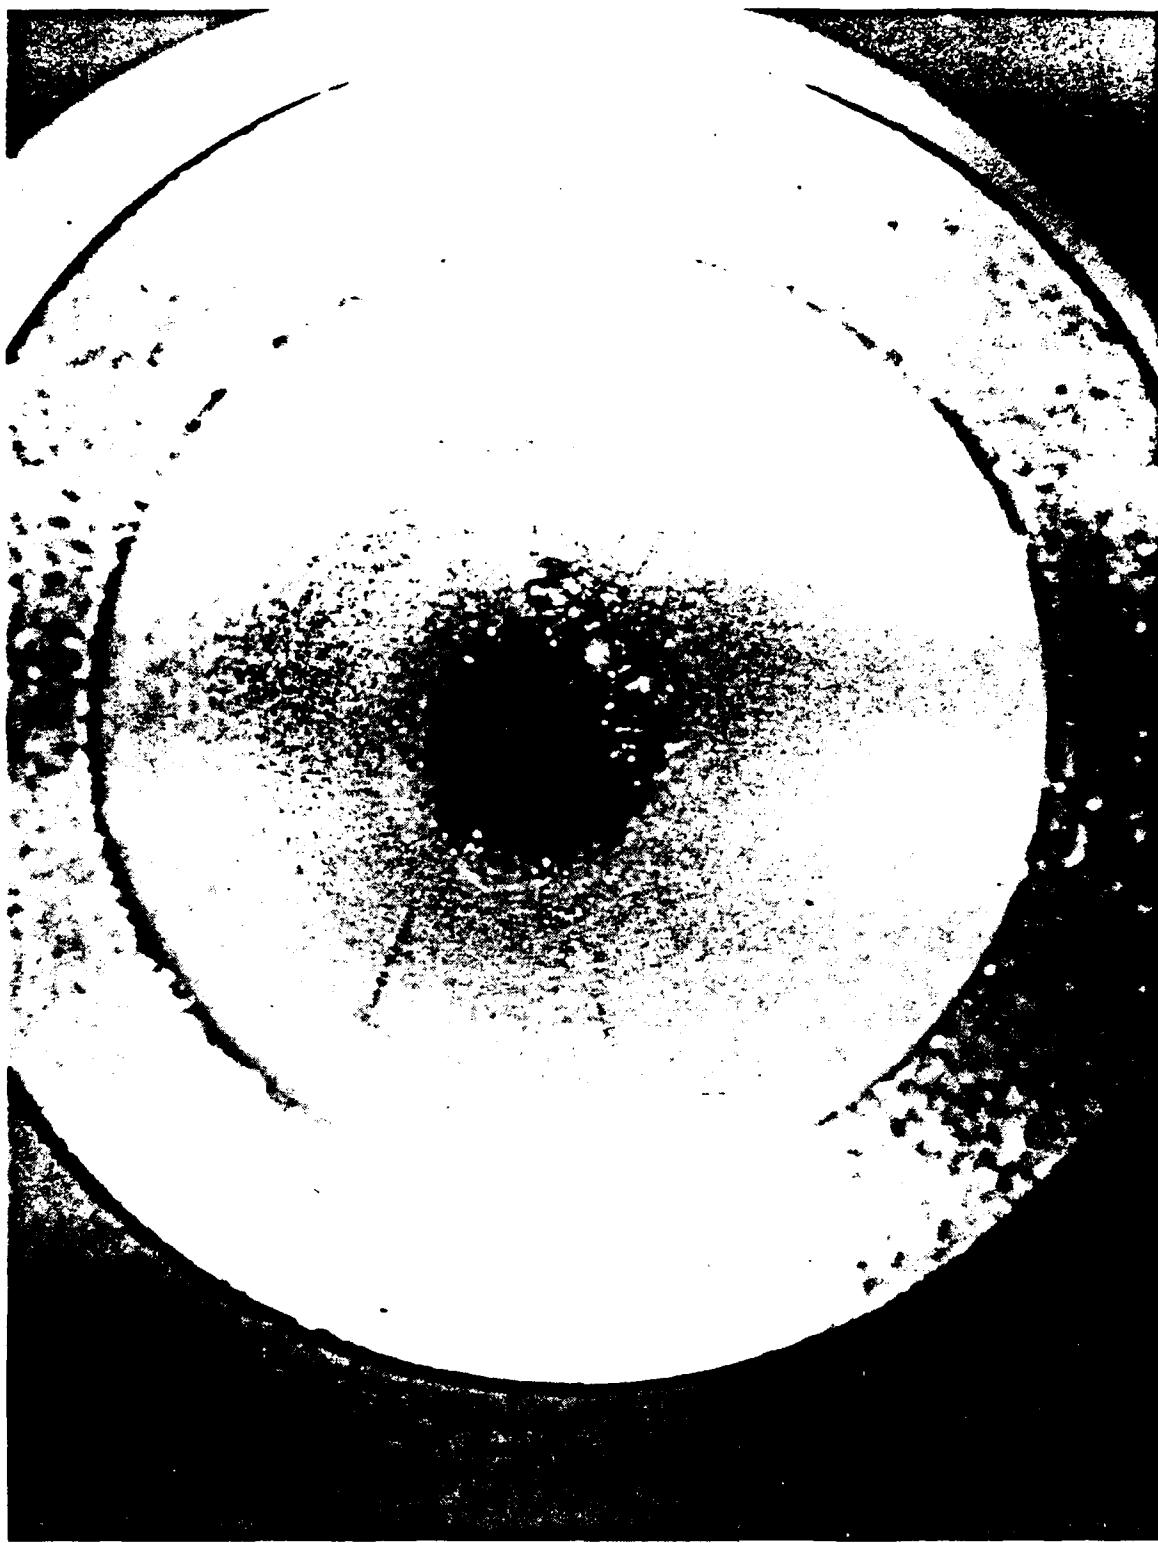
The engine was restarted after the inspection and the start was normal, as was the transition from argon to ammonia with the power at about 10 kW. When the power was increased to about 16 kW a change in constrictor configuration occurred, as viewed from the diffuser, and the test was terminated. This time, on inspection, it was found that a great amount of damage was done to the constrictor wall. This damage can be seen in Fig. 35, taken after the engine was removed from the thrust stand. The engine was only then disassembled and carefully inspected and analyzed.

Figure 35. Close-up of Nozzle and Constrictor After Attempted Restart

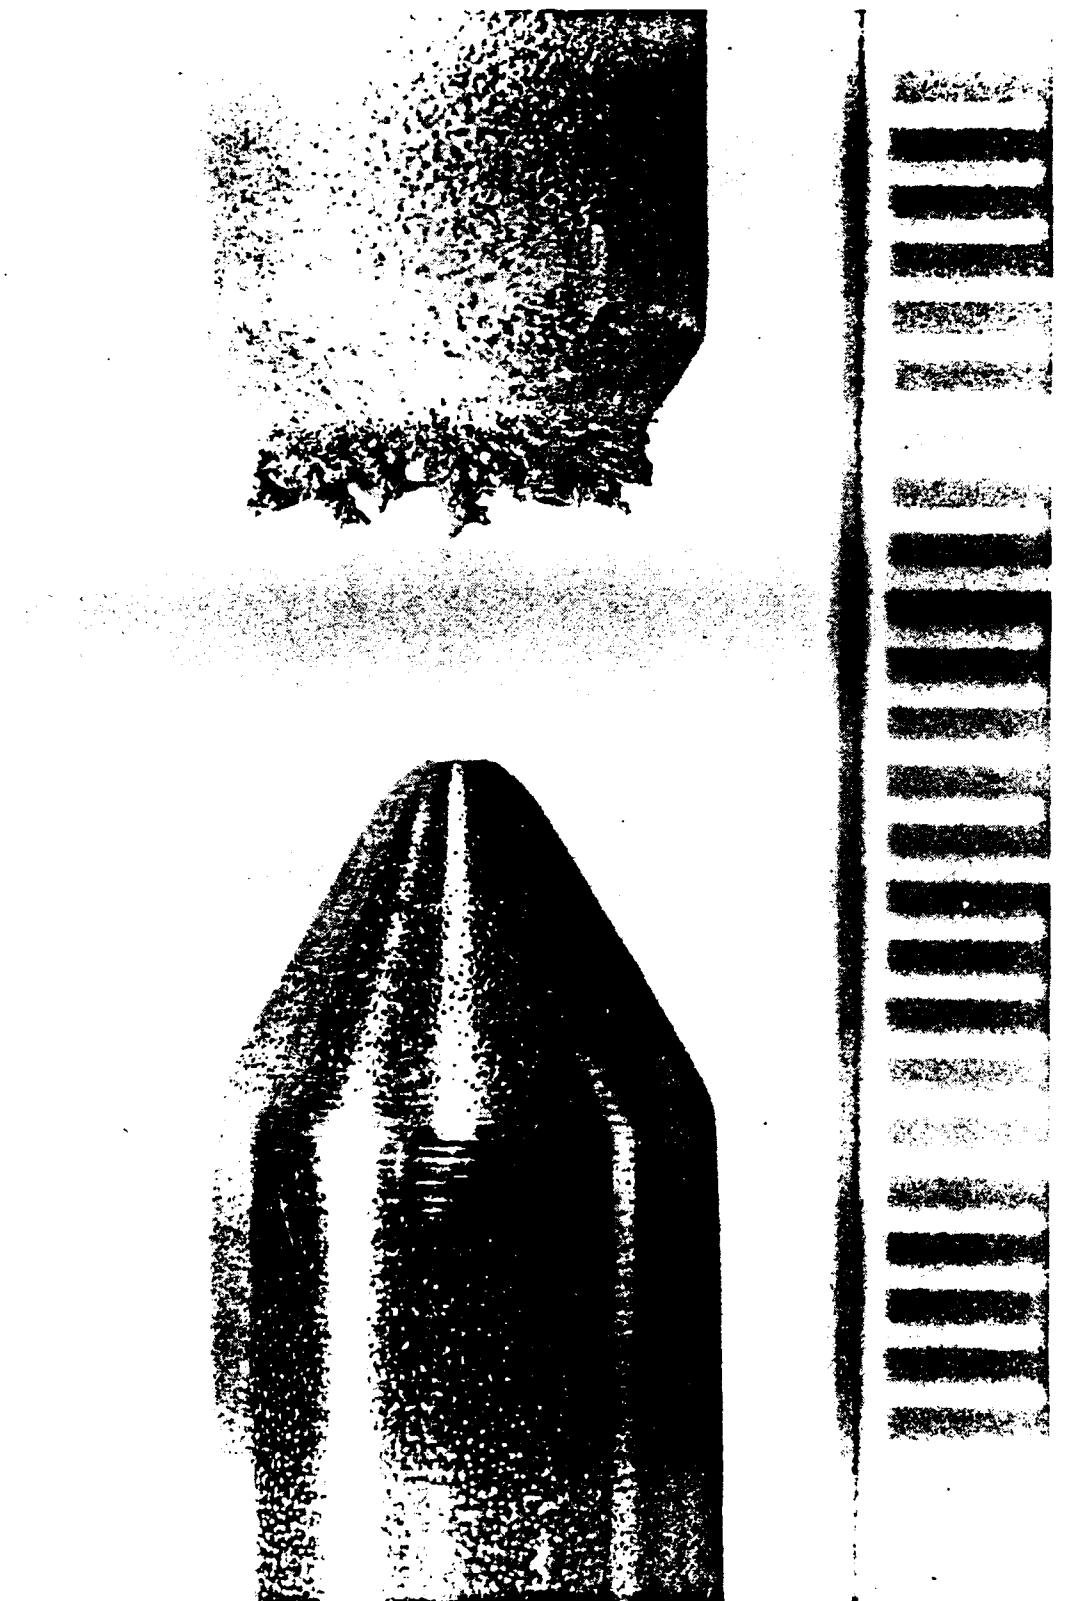
Beside the constrictor damage, which was sustained after termination of the long duration test, the only major effects of the test on the engine were erosion of the cathode tip, the constrictor wall, and of the propellant injection nozzle. A side view of the cathode tip before and after the long duration test is shown in Fig. 36. The before picture is of a second cathode machined to the same specification as was the used cathode. Note the crystal growth around the periphery of the central hemispherical cavity first noted at 109 hours and then again at 369 hours. It is surmised that one of those crystals grew long enough to either touch the anode near the constrictor entrance or got close

Figure 36. Close-up of Cathode Tip Before and After 573 Hours of Accumulated Run Time

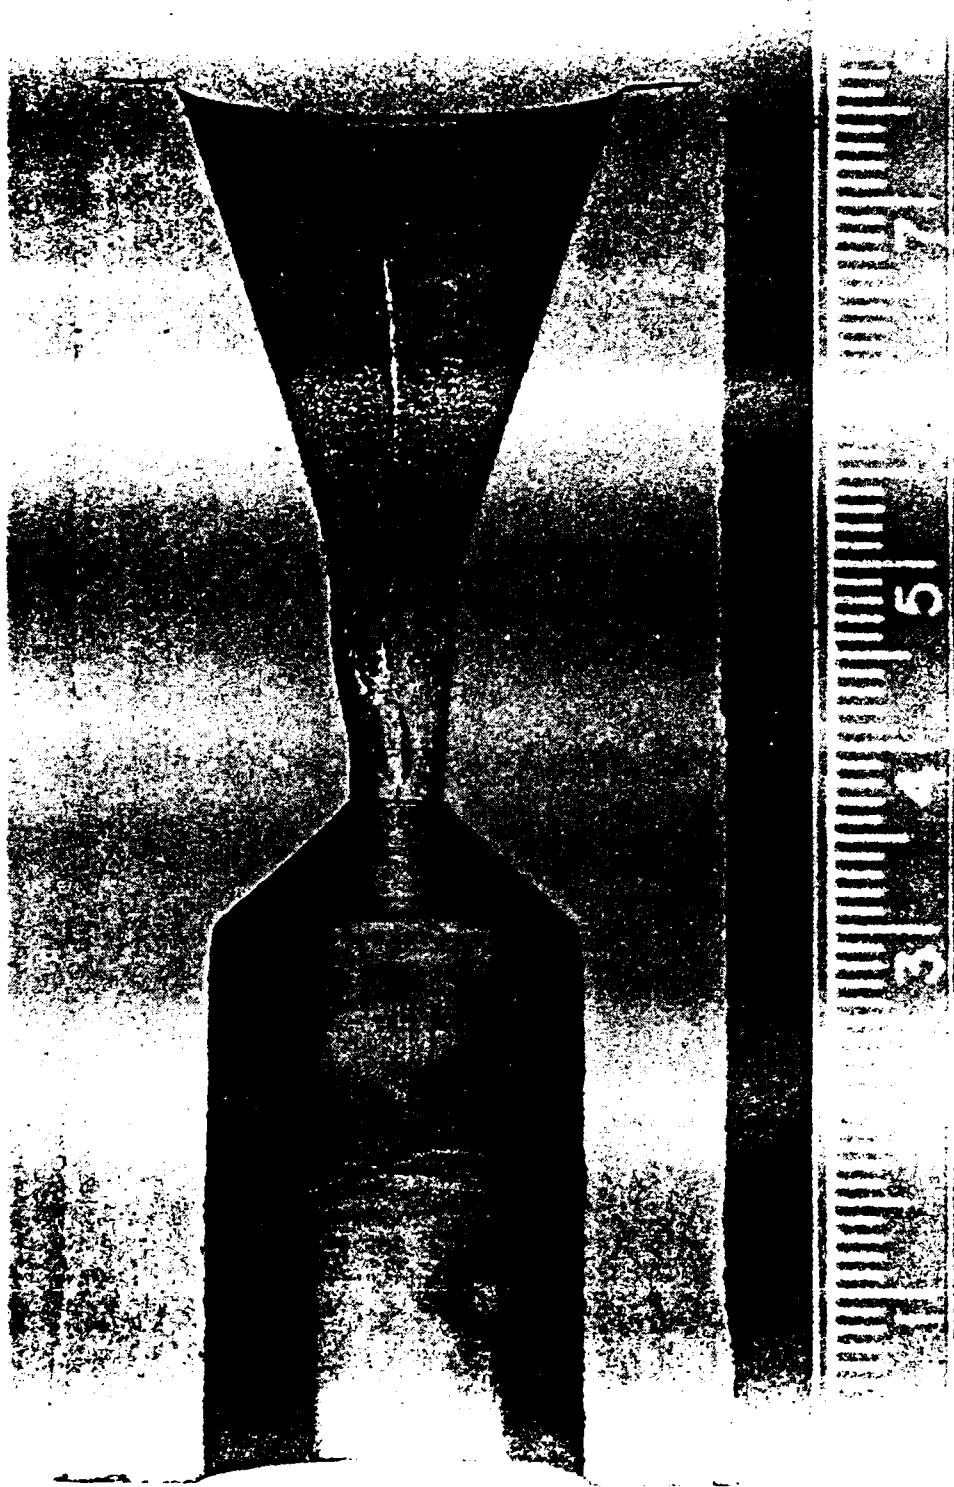
Figure 39. Sectional Anode Block After 573 Hours of Accumulated Run Time. This is the Least Damaged Half

After completion of the long duration test and subsequent attempt at a restart the anode-nozzle was sectioned and the least damaged half was ground flat and smooth. A picture of this half is shown in Fig. 39. The lower contour of the constrictor was undamaged and clearly shows the erosion pattern caused by the long duration test. This contour was carefully measured and the results plotted on a large scale and compared with the original pre-test shape. As can be seen in Fig. 39, the erosion starts at about 1 mm into the constrictor. The constrictor radius then starts increasing at an ever-increasing rate for the next 6.5 mm, is then constant at 3.0 mm for the next 4.0 mm and then slowly blends into the 19° half angle cone. The erosion ends about 4 mm into the expansion nozzle. By performing a graphic integration on the data, the amount of tungsten eroded was determined to be 0.071 cm³ or 1.37 gms. A careful inspection of the nozzle contour part of this plot indicates that material may have been deposited on the nozzle wall starting about 11 mm from the exit plane. The thickness of this deposited layer increased linearly and reached about 0.2 mm at the exit plane. The volume and mass of this layer was calculated to be 0.075 cm³ and 1.45 g. Note that these determinations are at best an estimate since they involve very small changes in radius, 0.5 mm for the constrictor and 0.2 mm, maximum, for the nozzle. However, the results suggest that there is little net mass loss due to normal operation.

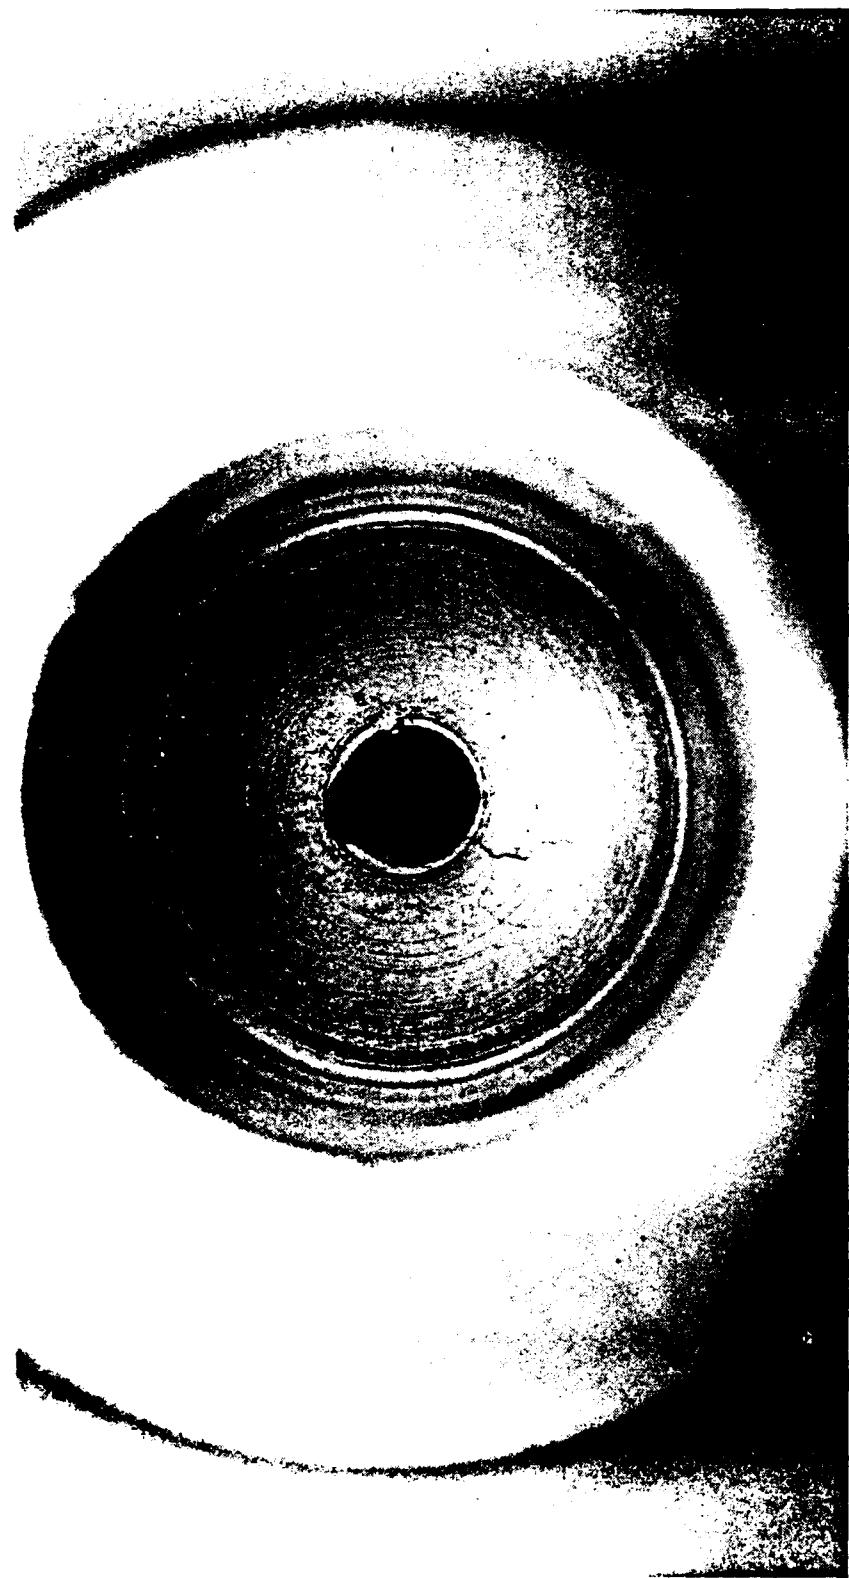
The extent of this cracking is shown in Fig. 40, which is a picture of the plenum chamber side of the constrictor. This picture also shows the damage sustained by the constrictor wall during the attempted restart. A more extensive pattern of cracks is shown in Fig. 41. This figure is a picture of the constrictor entrance of an engine used for engine development testing. This engine sustained many starts and shutdowns over a variety of conditions, resulting in the much more extensive cracking.

Figure 40. Photograph of Plenum Chamber End and Constrictor
Entrance After 573 Hours of Accumulated Run Time

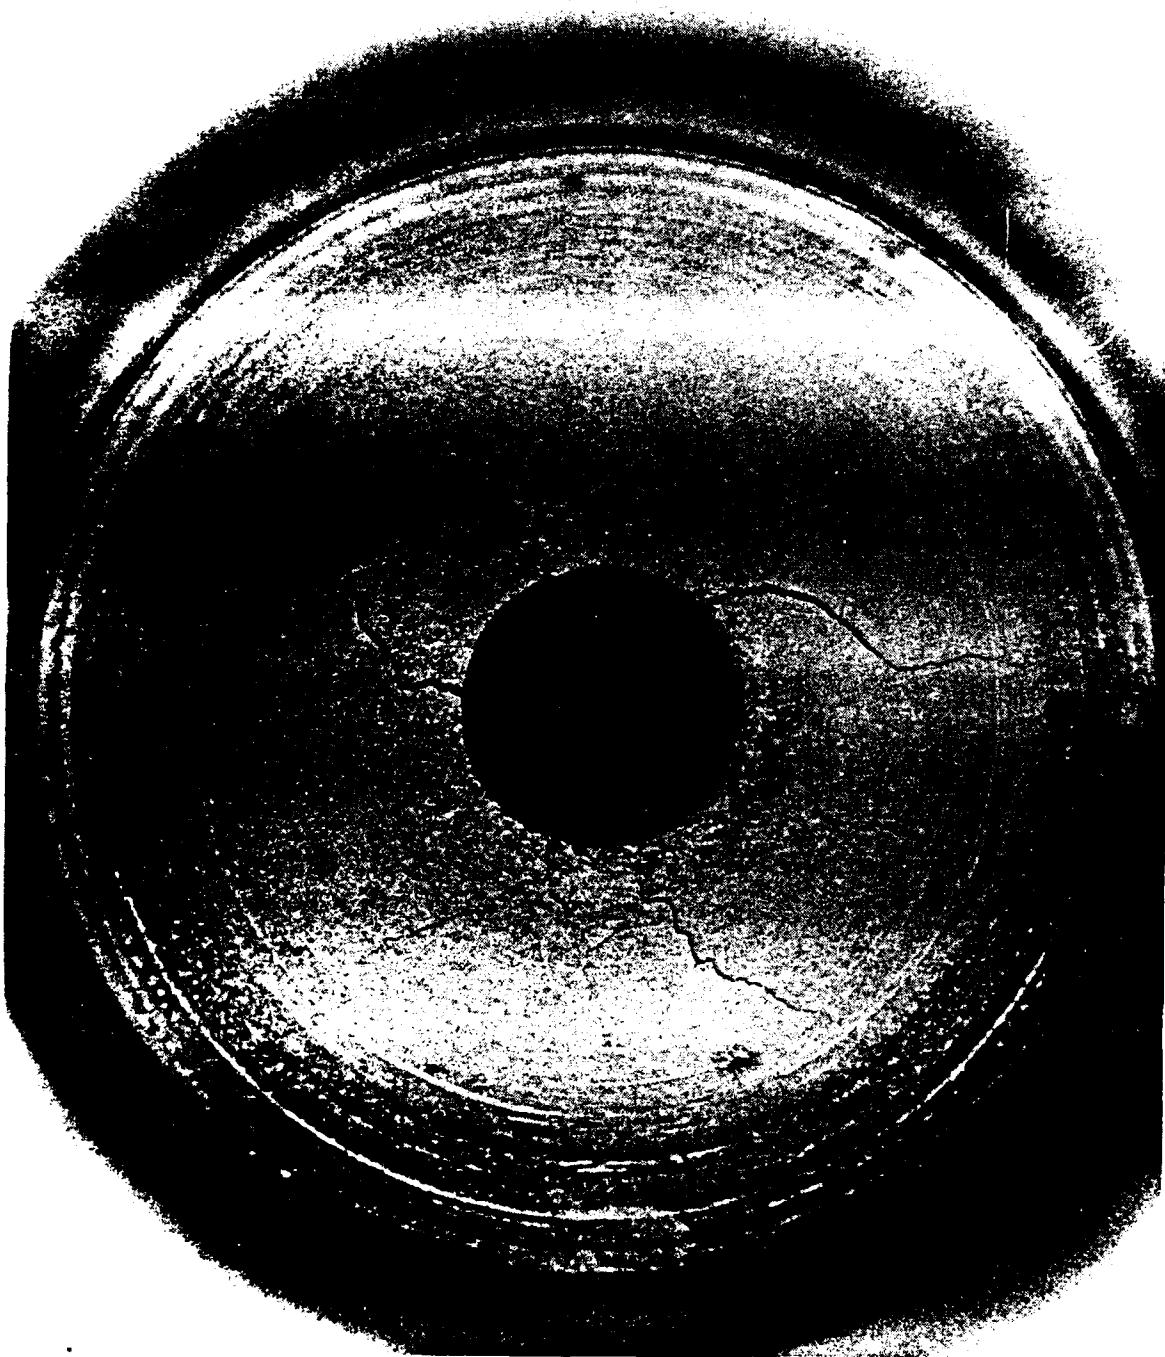
Figure 41. Photograph of Plenum Chamber End and Constrictor
Entrance of Developmental Engine After Many Starts

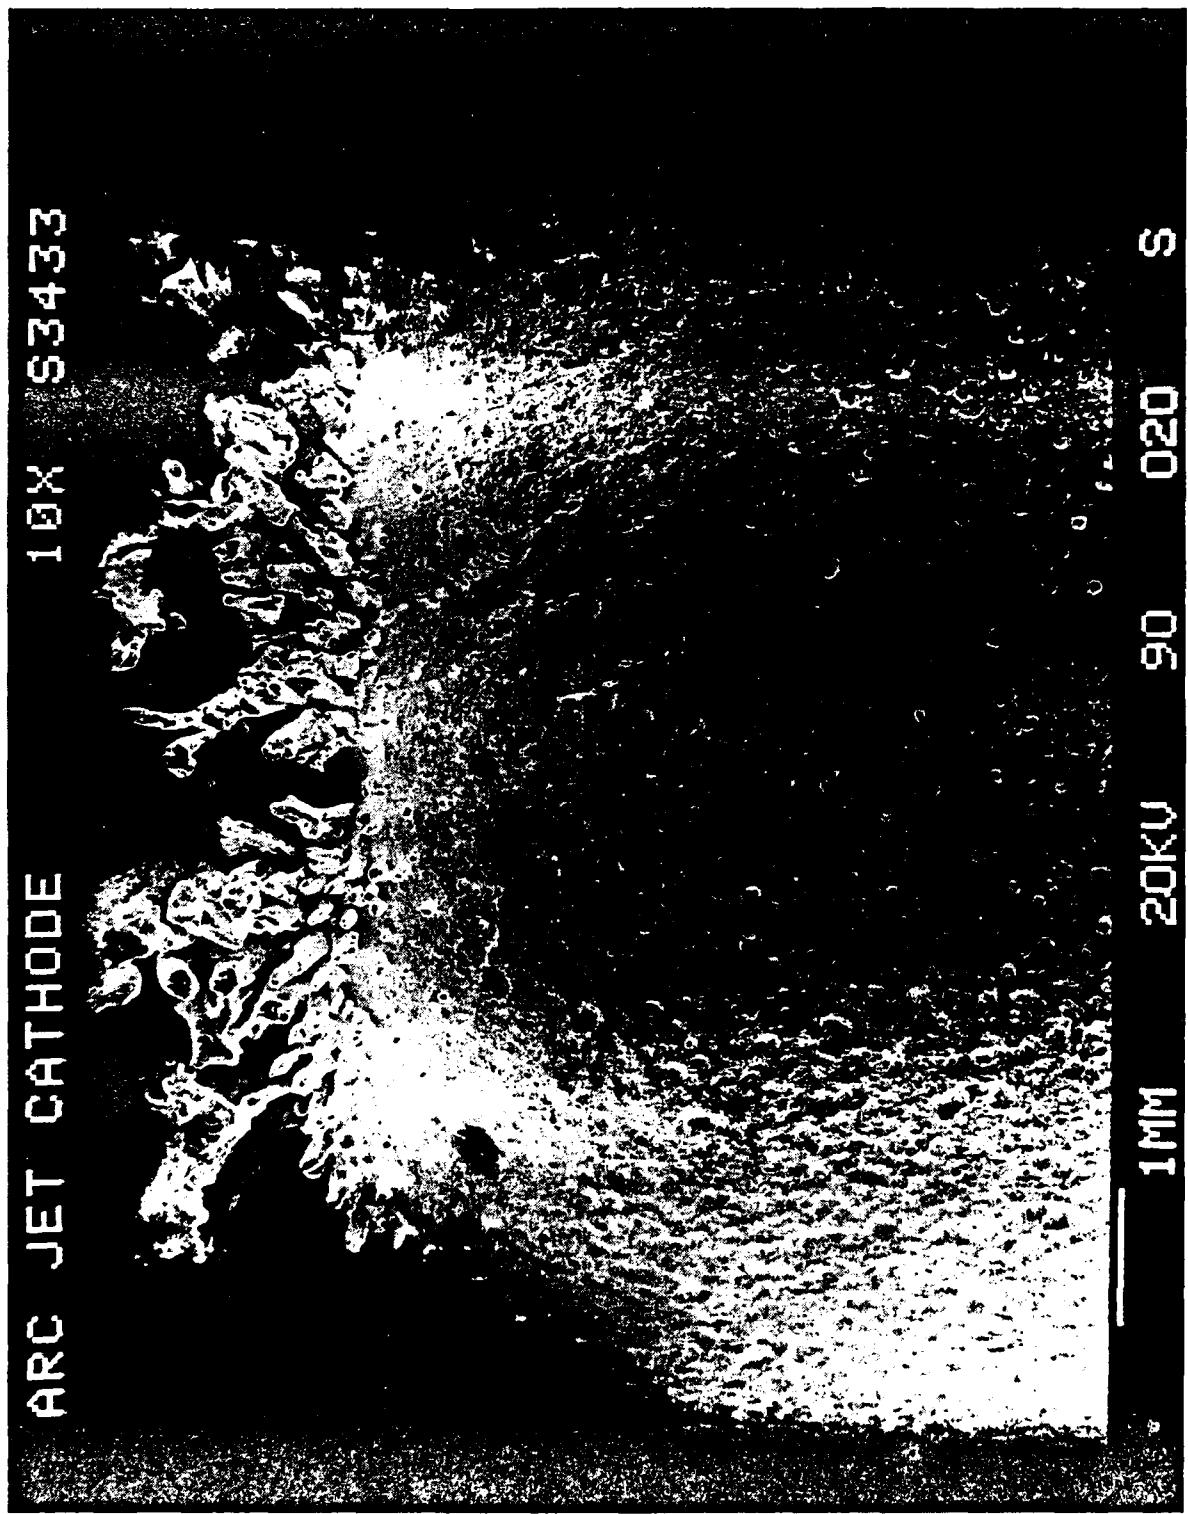
Figure 42. SEM Side View of Cathode Tip After 573 Hours of
Accumulated Run Time

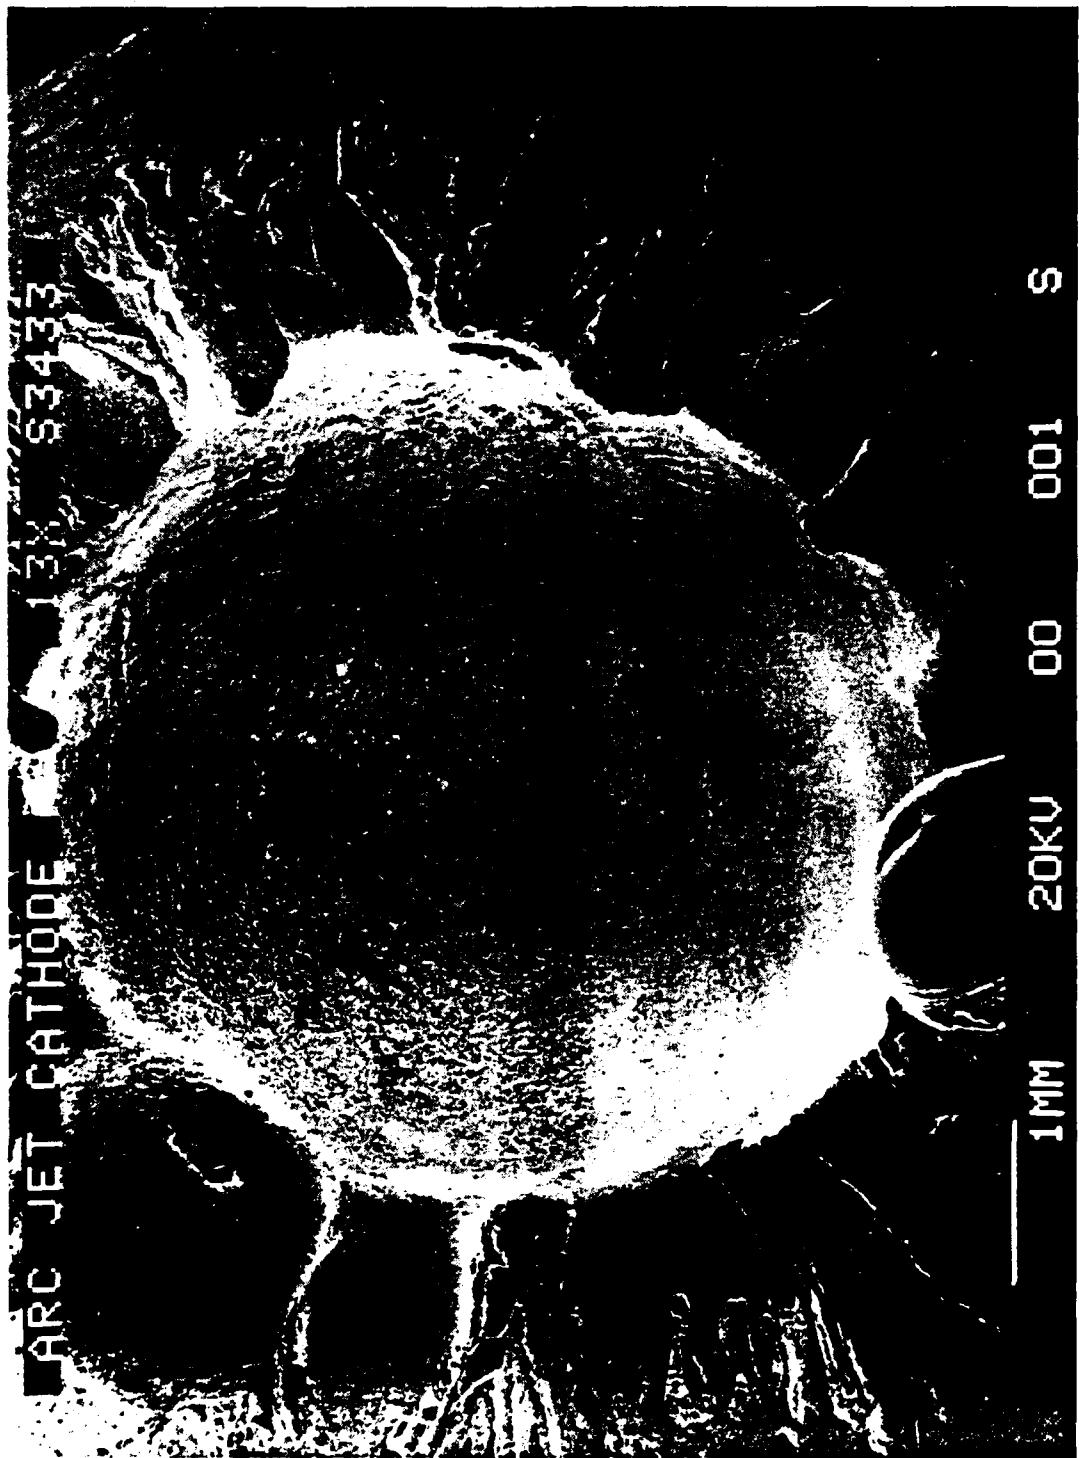
An end-on view of the cathode tip is shown in Fig. 46. Notice that the shining ball of Fig. 38 is at the bottom (6 o'clock) and seems to have a dimple at its center. A second ball, with a rough surface and a central dimple, can also be seen at about 10 o'clock. A close-up of the dimples is shown in Figs. 47 and 48 for the shining and rough balls, respectively. Both appear to be vent holes for escaping gases. Notice that the rough ball surface is covered with arc micro-spots, indicating that this ball was formed some time before the test was terminated. Arc micro-spots were also found over most of the surface of the central crater as can be seen in Figs. 49 and 50. Notice that the whiskers created by splashed molten tungsten, out of the micro-spots, are much smaller in diameter than the crystal whiskers and that the micro-spots are of order 20 to 40 μm in diameter.

Figure 46. SEM Overall View of Cathode Tip Crater, Whiskers and Tungsten Balls

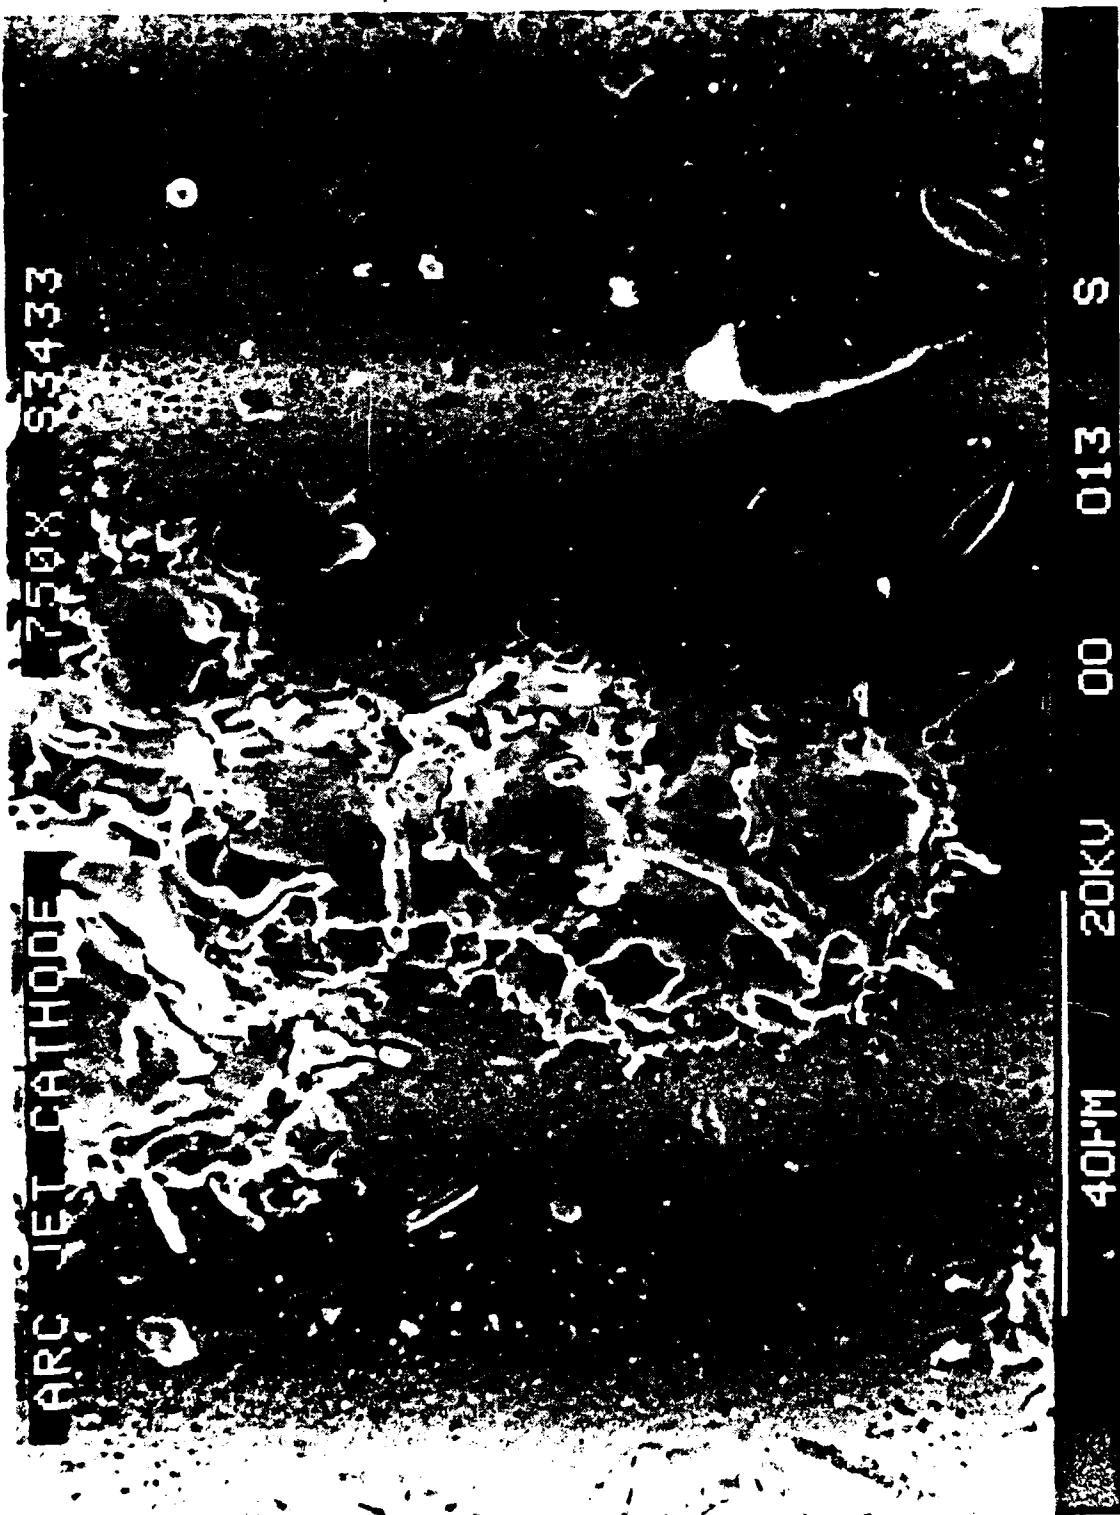
While most of the central crater surface was covered with arc micro-spots, indicating intense thermionic electron emission from this surface, the cathode outer cylindrical surface had none. Instead, this surface was found to be covered with approximately 50 μm diameter pits and with crystal facets, as can be seen in Figs. 51 and 52. The thermionic electron emission current density from this surface was probably much lower than that of the crater but there may have been substantial field emission from the sharp crystal edges. Where this surface was covered with the boron nitride insulator, see Fig. 9, the surface was smooth, unpitted and still showed machining marks. The cathode tip cone surface also was covered with pits and crystal facets but no micro-spots.

Figure 49. SEM Close-up of Cathode Crater Surface Showing Some Arc Microspots and Some Smooth Tungsten Surface
